OSTELECTRIC

**Installation and maintenance
of drum brakes type NC
with electro-hydraulic thrustors**

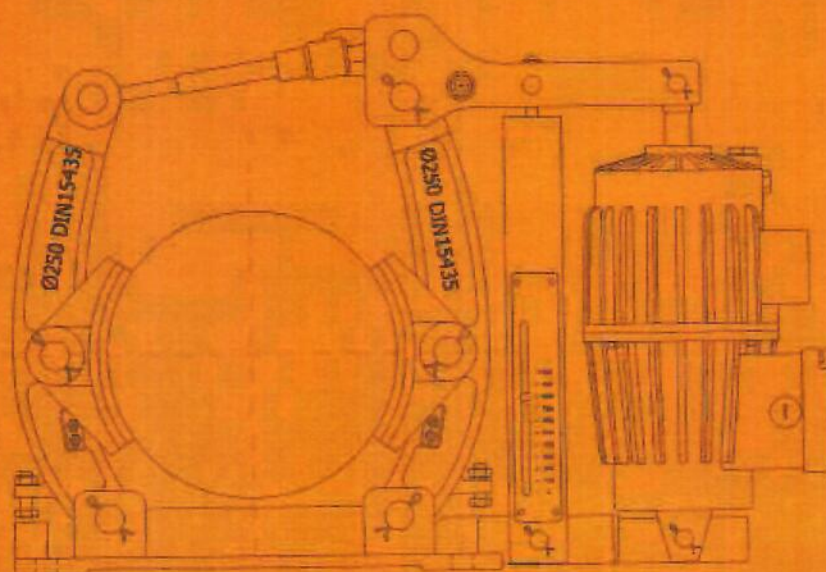
Preparing supporting plane

The brake must lie on a plane surface provided with 4 fixing bores diameter $(d - 1)$ at distance b from drum axle and at mutual distance f on transverse axis. As the brake structure is self-holding the machining of the whole supporting plane is not required, but just the contact surface $l \times c$ around the brake feet. The supporting plane must lie at exact distance h from drum axle.

The 4 fixing screws must be strongly tightened.

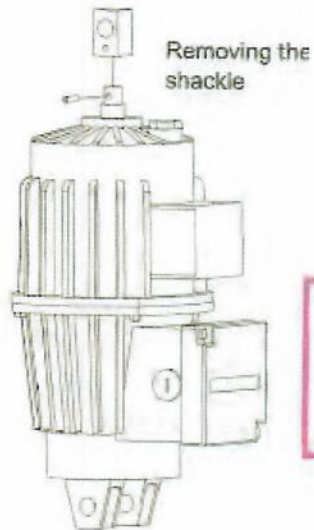
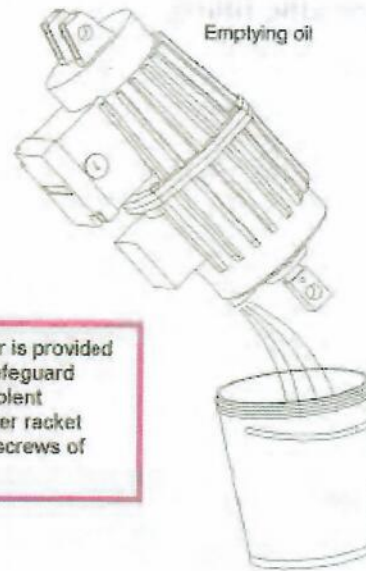
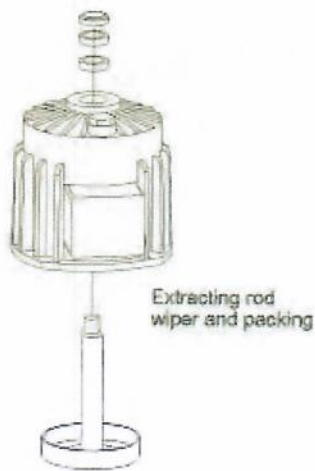
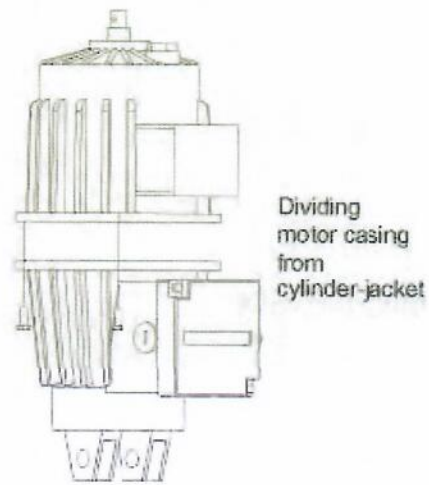
Replacing rod packing

Beware: If the thruster is provided with internal spring, safeguard yourself against the violent expulsion of the cylinder racket after loosening the 4 screws of the casing.

Re-insert the new packing and wiper and set again the thruster following the other way around

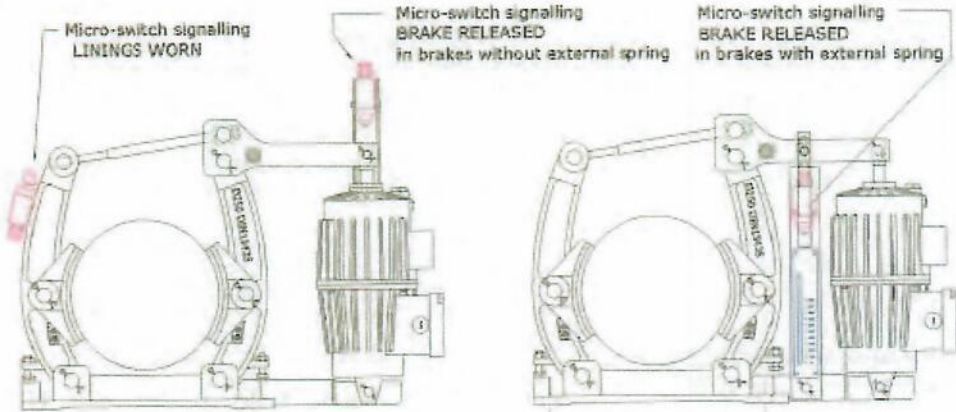
Micro switch

Micro-switch connection

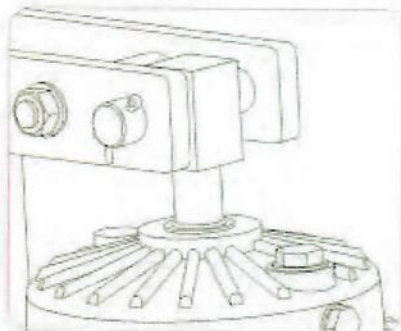
Correct piston stop-position at applied brake

Verify the piston position. Take into account that gradually the linings wear, the piston stop-position will be lower and lower until the end position is reached, where the braking effect will miss with great danger for the personnel safety.

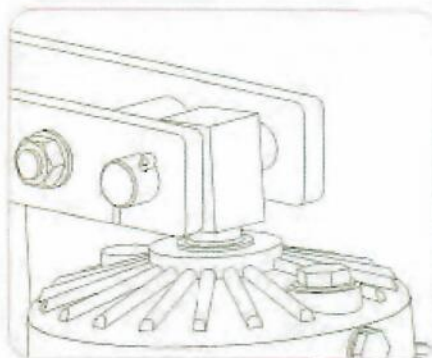
Wrong piston stop-position at applied brake. Danger!!!

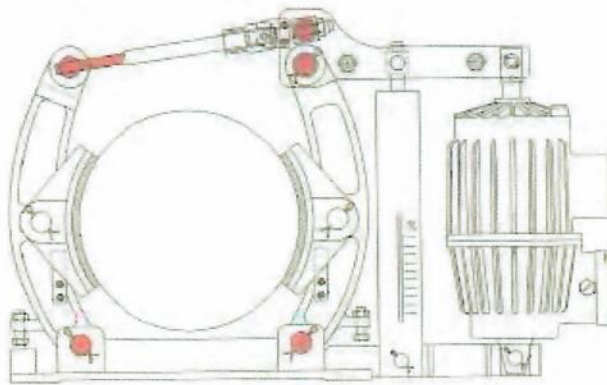
Greasing

Every three months the brake has to be greased. Grease is better than oil as the latter rapidly leaks and ends up make onto the linings, thereby reducing the braking performance. It is worth using a dense product to grease al pins and joints and avoiding the

drum braking surface. A good periodical greasing not only is essential for the brake function but makes last it longer.

All pins have to be greased, but particular care must be devoted to the ones marked in red color in the above picture. If the brake is equipped with automatic lining wear compensator the portion of threaded bar of the rod – just close to left pin – has to be greased as well.
